Case Study: CH-1946

3D TRASAR™ TECHNOLOGY FOR BOILERS WITH NEW HARDNESS RESPONSE PROGRAM HELPS U.S. REFINERY ENSURE MAXIMUM BOILER RELIABILITY

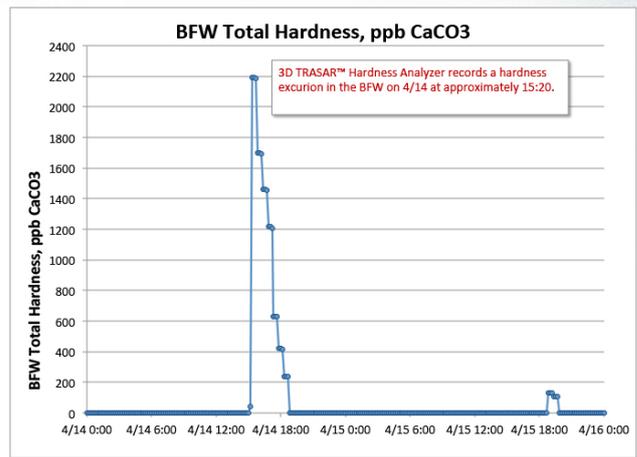
Figure 1 - 3D TRASAR Technology for Boilers System detects hardness excursion.

However, the Nalco Hardness Analyzer has picked up several excursions since its implementation. One example is shown in Figure 1 where there was a major excursion observed on the afternoon of April 14th, with the hardness level hitting approximately 10 times the ASME limit.

The excursion was later found to be attributed to a problem experienced on the regeneration of one of the sodium zeolite softeners.

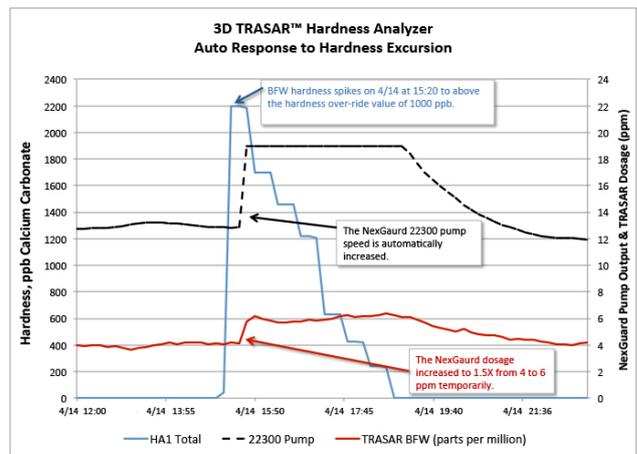
Figure 2 - 3D TRASAR Technology for Boilers System automatically responds to the upset condition.

The 3D TRASAR Technology for Boilers System not only detected the hardness excursion, but also took immediate action. The NexGuard™ internal treatment product pump

speed was increased, and correspondingly the NexGuard all polymer program dosage was increased to the new set point (1.5 times the normal set point) as shown in Figure 2.
